SPRINT ***BOOSTER*** ***POWER CONVERTER***

Installation guide for Sprint Booster #SBAU0011,
Audi A5/S5 2007+

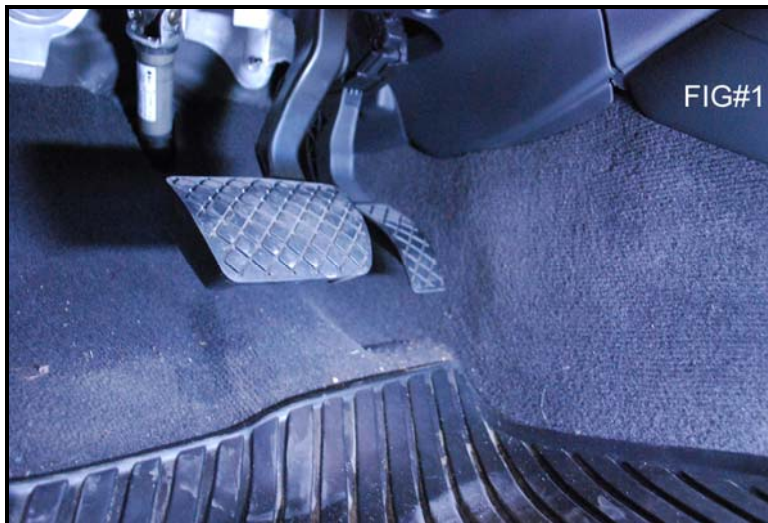
Step 1- Turn off Ignition. Get yourself in position to work just above the gas pedal assembly. Your pedal area should similar to Fig #1

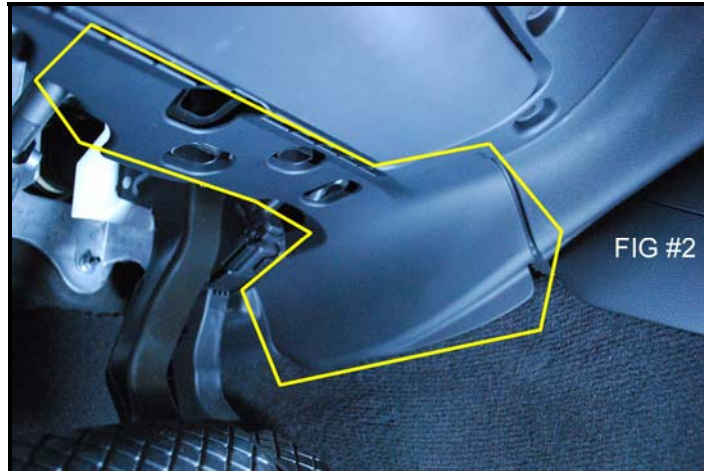
Step 2 – Remove the upper part of the cosmetic cover along the lowest part of the dash that is just above the gas and brake pedal. Shown more in Fig #2. It will not need to be totally removed, it only has to hang loose for the install of the Sprint Booster.

The highlighted shroud will remove with little effort, no tools are needed, a healthy downward pull will release it of its holding clips.

**Step 6- The Sprint Booster install is complete! Re-attach the plastic shroud removed in fig #2.
Go for a drive!**

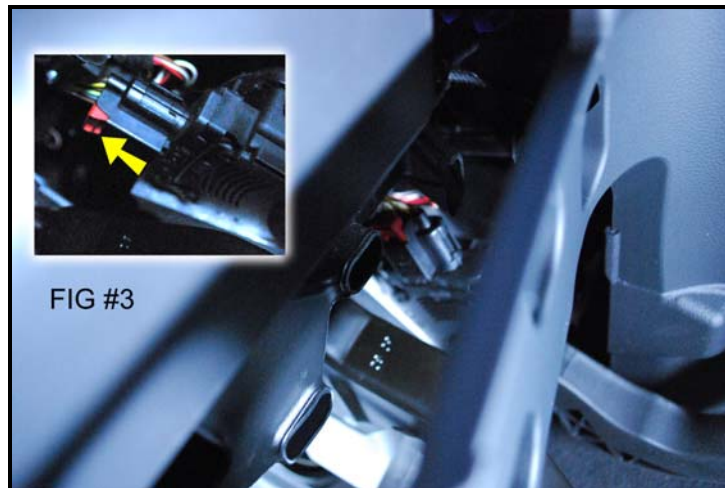
Step 3- Now that the small shroud is loose, you will see a connection with a red tab above the gas pedal. Fig #3

The red tab acts as a locking device for the connector to stay attached. Unlock the connection by pressing the red tab upwards.

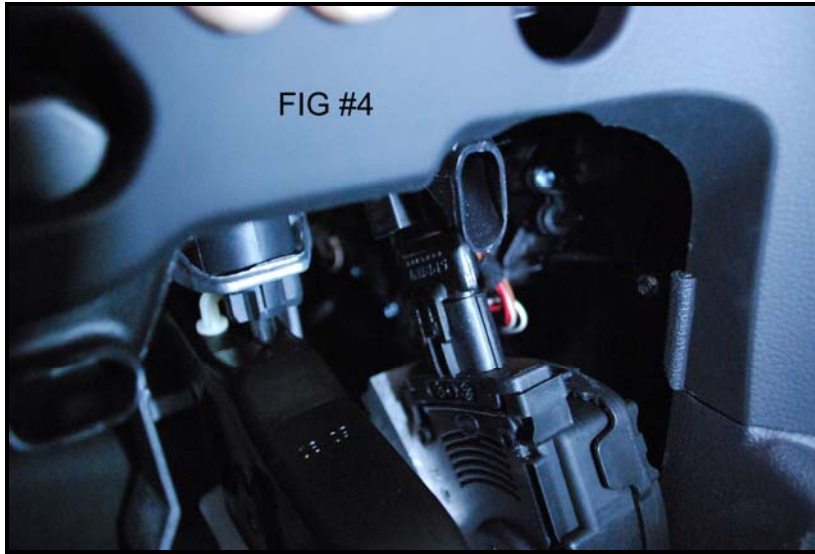
Step 4- While keeping the cosmetic shroud out of the way, remove connection from the gas pedal. This is where the Sprint booster will be inserted. Get familiar with how the Sprint Booster should be plugged in. It will only install successfully in one direction. The fork in the Sprint Booster will face to the left and downward in the pedal. Proper installation is shown in Fig #4.

You may find the heating vents to obstruct the alignment of the Sprint Booster. The vents will move a bit to one side.

Step 5 – Also shown in Fig #4 is the OEM harness connection to the Sprint Booster. Plug in the harness to the Sprint Booster in the same position as it was installed on the pedal. Relock the connection with the red tab pressed downward.
